# LIMITED MOLD AND MOISTURE ASSESSMENT

PATRICK HENRY SWING SPACE

ECS PROJECT NO. 47:1519-Q

FOR: ALEXANDRIA CITY PUBLIC SCHOOLS

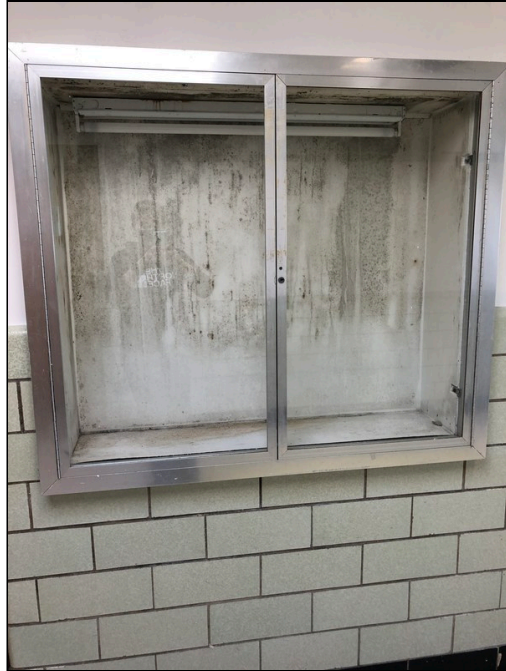
ECS performed a non-invasive visual survey in Classrooms 1044, 1046, 1055, & 1057 and the adjoining hallway. ECS observed suspected mold growth within a display case in the subject hallway. ECS also observed suspected mold growth on the fiberboard decking in the ceiling cavity. Note that the asbestos-containing white acoustical plaster ceiling was recently abated within the subject section of hallway which allowed ECS to observed the fiberboard decking within the hallway. The fiberboard decking may be impacted in other areas within the scope of work that ECS was unable to access.

1 - Display case in hallway with visible microbial growth

ECS recommends remediation be performed for all water and mold impacted materials within the surveyed areas as soon as reasonably possible. This includes all materials that have visible mold and have been subjected to elevated moisture conditions for greater than 48 hours without proper drying efforts. It is ECS's understanding that the source of the water intrusion has been identified and addressed. If this is not accurate, ECS recommends the source of the water intrusion be identified and remediated prior to abatement efforts.

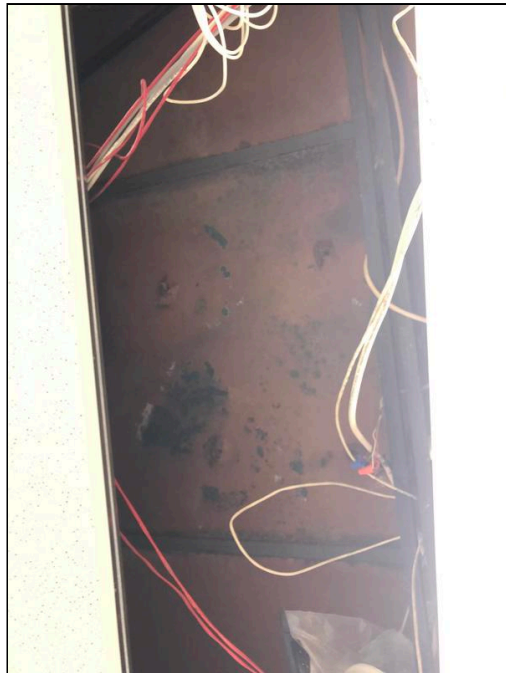
2 - Visible microbial growth above drop ceiling in the hallway

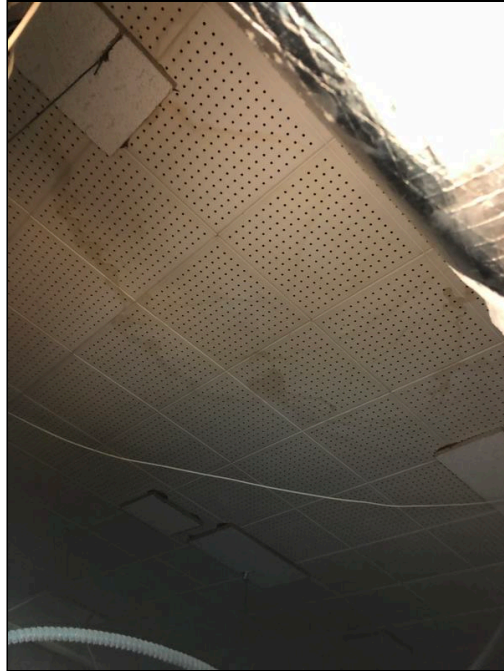
ECS observed water staining on the 1'x1' ceiling tile above the drop ceiling in each of the classrooms. Note that ECS was unable to observed the ceiling cavity above the 1' x 1' ceiling tiles.

3 - Representative photograph of water stained 1'x1' ceiling tile above the drop ceiling in classrooms

1. All visibly water stained ceiling tiles should be removed and discarded. This includes tiles that were previously stained and have been painted.
  - Replacement of the ceiling tiles with new, unstained tiles is important for several reasons. This documents that the water leak has been addressed. New, unstained ceiling tiles are also needed to identify recurring leaks for appropriate action.
2. All fiberboard decking and wall/display case materials that have visible growth should also be removed in excess of 2 feet beyond visible mold or water stains where feasible. Delineation of the wall and ceiling systems may be necessary during remedial efforts to determine if additional materials will need to be removed.
